Understanding Britain's ATLANTIC WALLS

INTRODUCTION

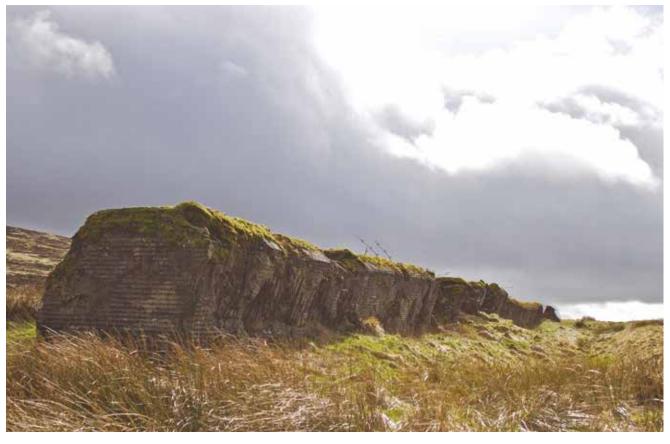
One section of the Sheriffmuir Wall as it looks now (2014). Laser scanning shows more detail and will even be able to render the wall to show it in its original state.

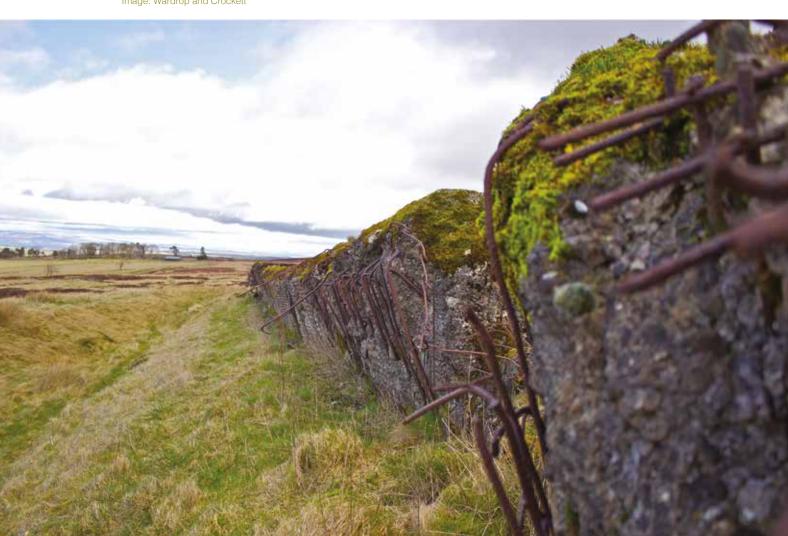
The concrete was reinforced with metal bars. The success of an explosive device could be measured by how deformed the metal bars were.

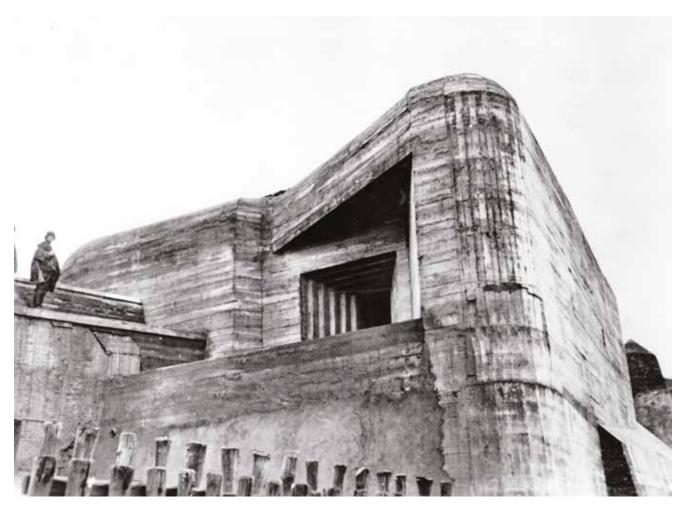
This is a solid concrete gun emplacement in 1943, in France. It gives an idea of the solidity of the German defensive structures that the Allies could expect to encounter.

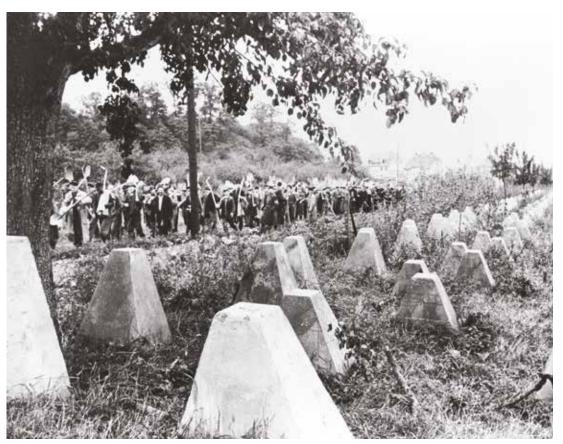
These concrete structures, in Northern France, were known as 'dragons teeth'. They presented an obstacle to tanks in WW2. The workers who built them file past in the background.

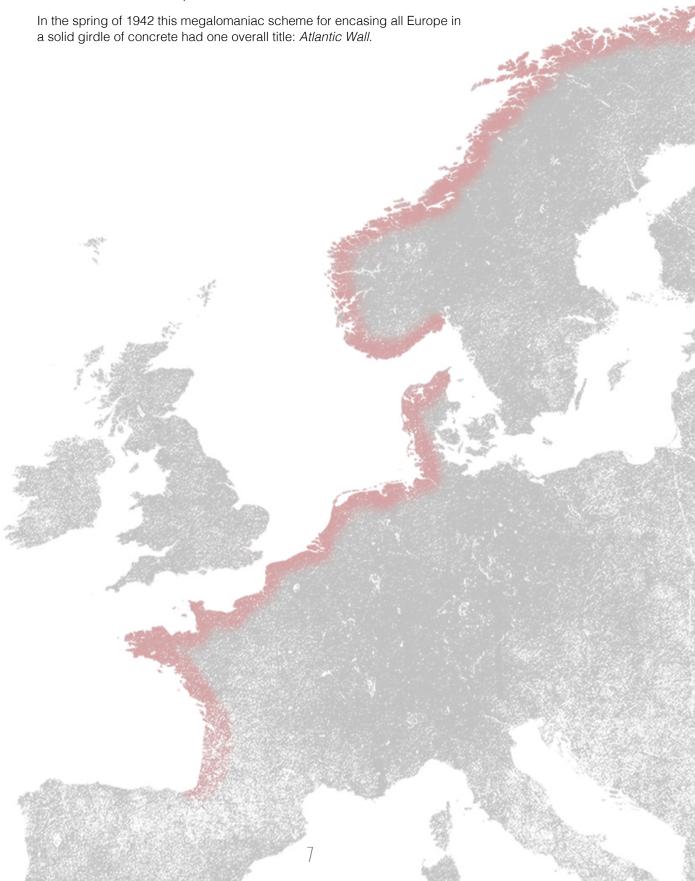
A series of concrete defence structures built along the west coast of Europe from the northern tip of Norway to Spain. Built by the Germans using slave labour, between 1942 and 1944, it was to protect against an anticipated invasion of mainland Europe from Britain.

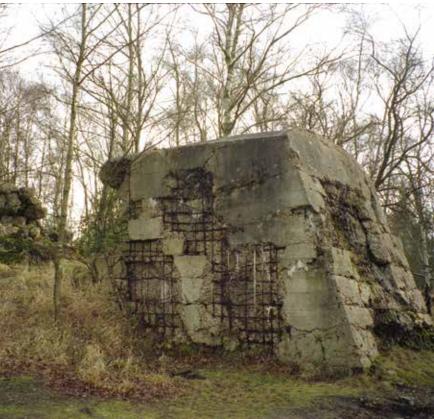
This circular Tobruk shelter gave protection for one man to crouch inside armed with a weapon. It is about 74cm (or 29") in diameter - a fairly tight fit. This one is at Sheriffmuir. 2014.

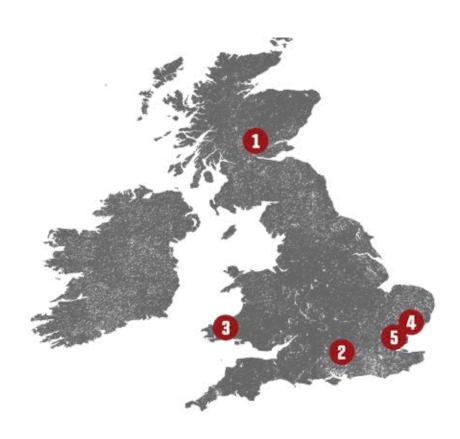
There are five known locations of UK Atlantic Walls:

- 1 Sheriffmuir, Perthshire
- 2 Hankley Common, Surrey
- 3 Castlemartin, Pembrokeshire
- 4 Sudbourne, Suffolk
- 5 Shoeburyness, Essex

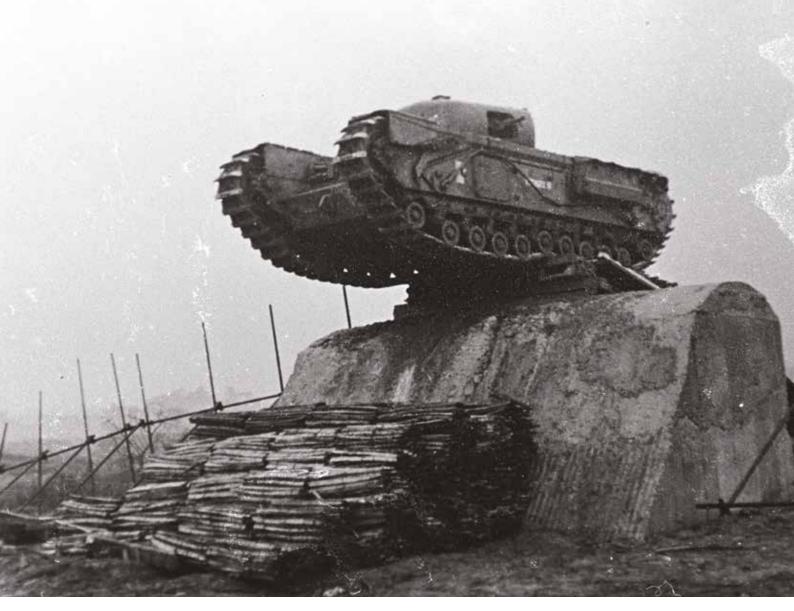
A Fascine - a bundle of wooden poles or rough brushwood lashed together with wires and carried at the front of the tank. It could be dropped to fill a ditch or form a step. Concrete obstacles modelled on the German beach defences were built as a training aid. This wall is at Orford, Suffolk.

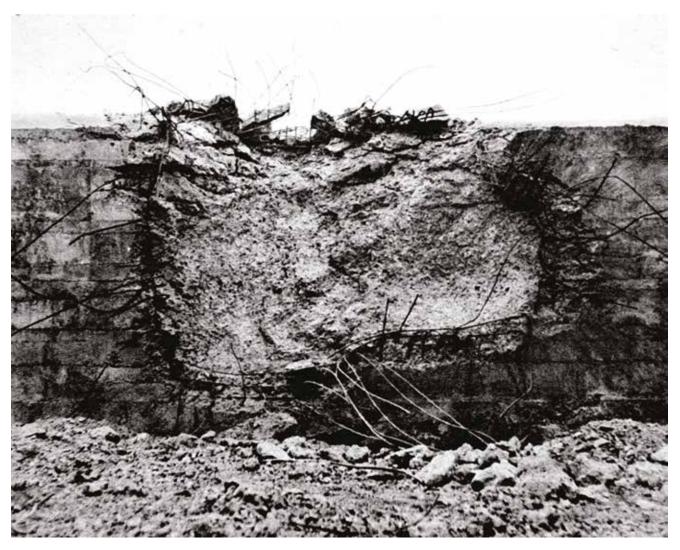
15 ^ 1944 Damaged concrete wall, France WW2 (caused by 'Flying Dustbins' the nickname for an explosive device fitted to a Churchill AVRE tank).

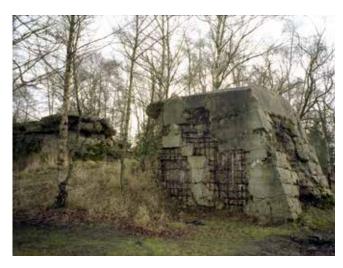
At Hankley Common, Surrey, the wall as it stands today. Explosive devices like "The Onion" created breaches in the replica concrete walls.

As well as the two massive breaches blasted in the Hankley wall by the explosives there are also many marks made by shells spalling off the concrete and snapping and twisting the reinforcement near to the surface. Other than this the wall must be very much as it was built, even though several more generations of troops have trained in the area which has provided military training since the inter-war period.

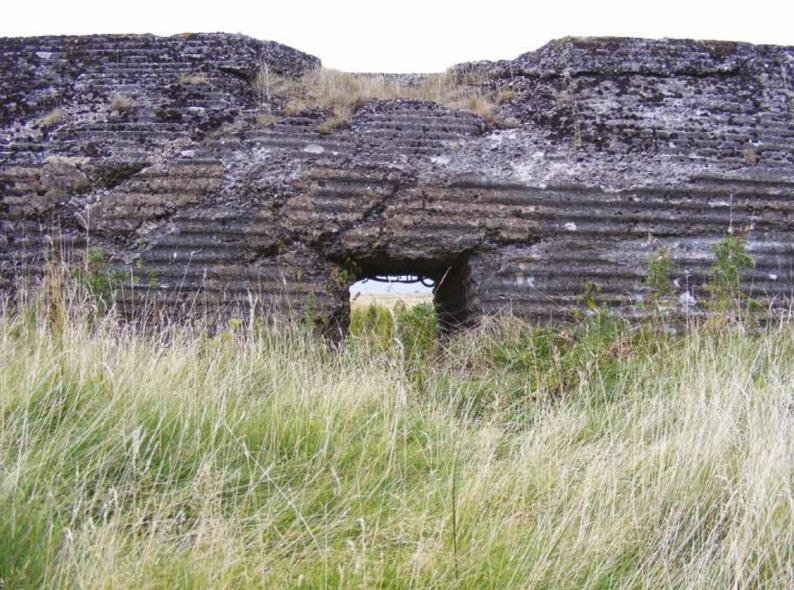
A small tunnel runs through this section of the Sheriffmuir Wall. The pattern of the corrugated iron sheets used for the shuttering in the construction of the wall are clearly visible.

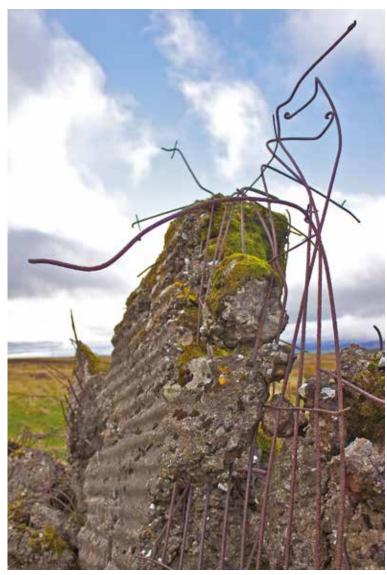
A damaged section of the wall exposing deformed reinforcing bars. It is quite likely that barbed wire was strung along the top of the wall attached to twisted iron 'picket' rods.

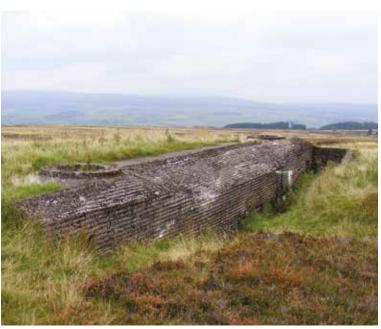
A well preserved section of the wall showing circular Tobruk shelters. One armed soldier could crouch down inside this shelter.
